MEMORANDUM

To:	David Pannasch
From:	Joseph D. Hudak, P.E.
Project:	Tink Wig Road Study
Date:	June 7, 2024

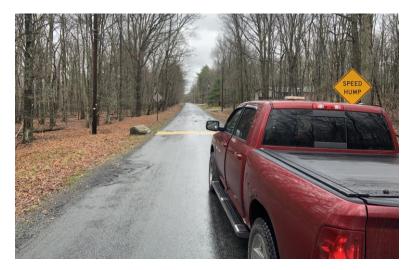
- A. Visual Inspection: An inspection was performed on April 12, 2024:
 - 1. Speed bump on Tink Wig Drive at SR 590: See Figure 1. The traffic calming element installed is a speed bump, not a speed hump as implied by the sign. Speed humps tend to be slightly smaller in height and longer than speed bumps; speed bumps are taller and more likely to be found in a parking lot. Both serve the purpose of slowing vehicles. Speed bumps will reduce the speed of vehicles to around 5-10 MPH; speed humps can be driven over at a speed of 15 to 20 MPH. The sign should read "Speed Bump" and be placed in-line with the speed bump; the boulders should be removed. A typical detail for a speed hump is attached; refer to the Speed Hump Notes for recommended locations and spacing, as well as markings.

Figure 1 – Speed bump on Tink Wig Drive

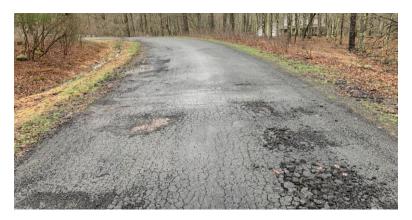
- 3. Parkwood Drive: Refer to Figure 2a. Roadway "sinking" at a culvert location is the result of:
 - Pipe failure.
 - Improper installation of the backfill material surrounding the culvert.
 - Insufficient cover over the crown of the pipe.

Figure 2a - Roadway deflection at culvert on Parkwood Drive

Inspection of the interior of the culvert revealed a slight deformation of the culvert but no "failure" (e.g. a pipe broken through-and-through at its crown); refer to Figure 2b. Thus, it is reasonable to conclude that the backfill surrounding the pipe was placed improperly and/or there was insufficient fill over the pipe.

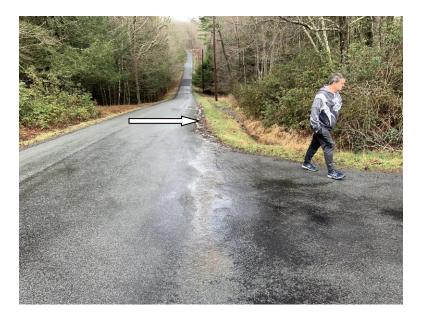
4. Tink Wig Drive and Parkwood Drive: Refer to Figure 3a. The condition of runoff along the edge of the pavement, with associated shoulder erosion is the result of the ground along the edge of the pavement being higher than the adjacent pavement edge. As a result, water runs along that pavement/ground boundary, instead of off the road surface, across

Figure 3a – Tink Wig Drive and Parkwood Drive:

the grass shoulder, and into the drainage swale. The remedy for this condition is to "scalp" the shoulders so the ground adjacent to the pavement edge slopes away from the pavement and toward the drainage swale. Refer to Figure 3b.

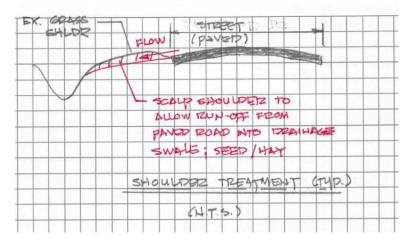
Figure 3b – Shoulder scalp

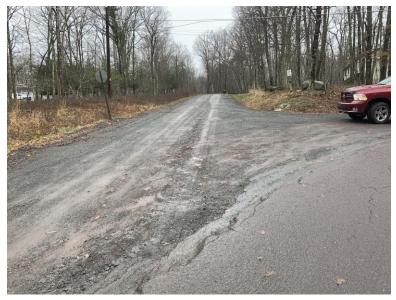
5. Cloud Crest Drive and Catamount: The current intersection geometry consists of a wide gravel throat for Catamount intersecting the superelevated asphalt roadway of Cloud Crest Drive. Refer to Figure 4a.

Figure 4a - Current Cloud Crest Drive/Catamount intersection

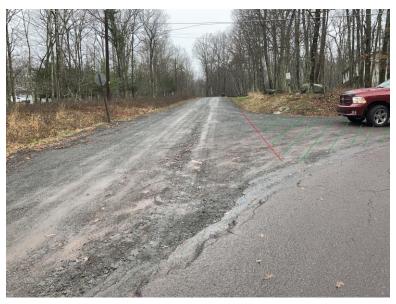
Figure 4b – Recommended geometry for Cloud Crest Drive/Catamount intersection

Refer to Figure 4b. Recommend extending the north edge of Catamount to the edge of Cloud Crest (red line) and replacing the gravel and asphalt with soils and grass (green lines). Grading should promote flow to the existing drainage ditch. Replacing the asphalt with grass will reduce the runoff. The narrowed intersection geometry will provide for slow speed turn into Catamount from southbound Cloud Crest.

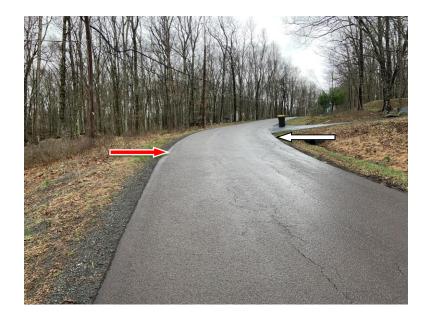
6. Catamount: Refer to Figure 5. Based on the curve geometry, the roadway appears to have an improper cross-slope (i.e. the outside of the curve (red arrow) is lower than the inside of the curve (white arrow)).

Figure 5 – Catamount improper cross slope

Depending on road surface conditions (e.g. wet, snow covered) and/or approach speed, a vehicle may leave the paved portion of the roadway along the outside of the curve. Recommend further engineering study to verify the roadway geometry and for a traffic barrier (e.g. guiderail) design.

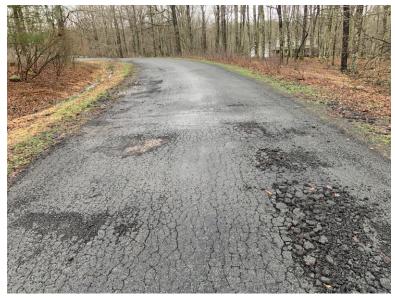
- B. Engineering Assessment:
 - 1. Preventative Maintenance:
 - Roads Bituminous roads should be maintained with a smooth and stable driving surface. Crack sealing and sealcoating (i.e. tar & chip) will add service life to a road surface. Roads with severe alligator cracking or deterioration (see Figure 6) are not candidates for either crack-sealing or sealcoating; these roads should be replaced.

Figure 6 – Example of a deteriorated road surface that requires complete replacement
